SATELLITE-BASED DAMAGE ASSESSMENT: TAWERGHA, LIBYA

Analysis conducted with satellite imagery recorded on July 28, October 21 and November 24, 2011 and May 25 and August 18, 2012.

SATELLITE-BASED DAMAGE ASSESSMENT: TAWERGHA, LIBYA (2011-2012)

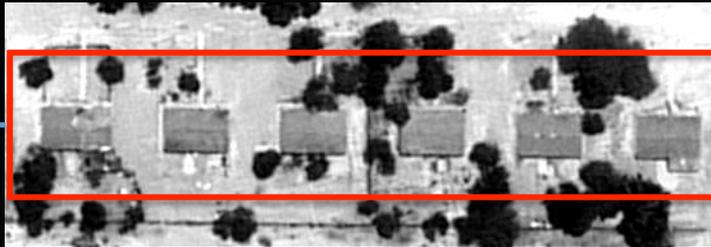
Imagery recorded on November 24, 2011

Imagery recorded on morning of May 25, 2012

Large residential housing complex likely destroyed in arson attack after November 24, 2011

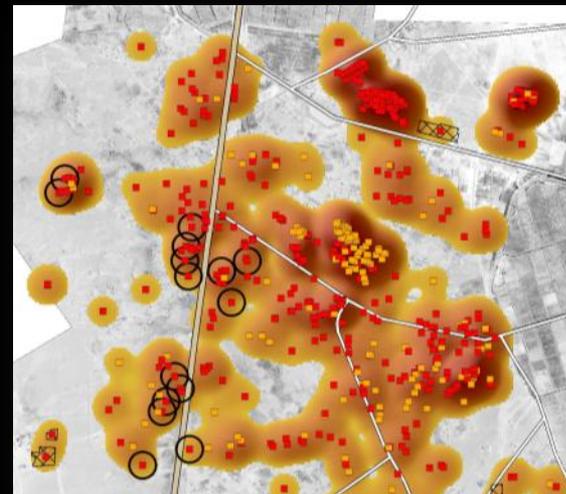
Relative density of identified building damages and probable demolition locations in Tawergha

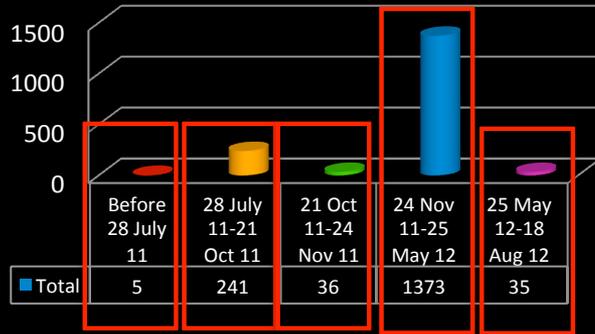
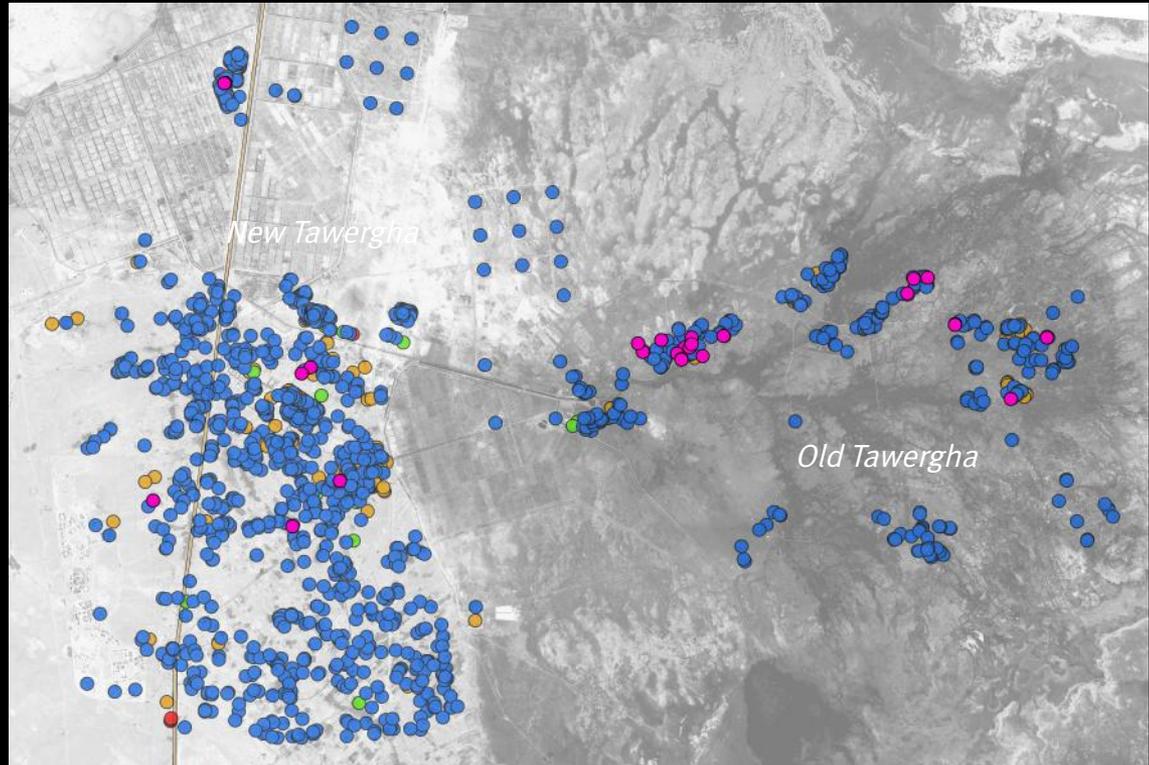
Building Damages by Date Period:

Building Damages by Date Period:	Total
Before July 28, 2011	5
July 28, 2011 to Oct 21, 2011	241
Oct 21, 2011 to Nov 24, 2011	36
Nov 24, 2011 to May 25, 2012	1373
May 25, 2012 to Aug 18, 2012	35
Total Damage Sites Identified:	1690

- Before July 28, 2011: Five destruction sites (probable NATO air strikes; one site confirmed with video);
- Between July 28 and October 21, 2011: Additional air strike building damages (<25) with initial round of arson attacks and demolitions, concentrated in new Tawergha;
- Between October 21 and November 24, 2011: Apparent pause in building destruction with 36 identified damage sites, all in new Tawergha;
- Between November 24, 2011 and May 25, 2012: Main phase of building destruction with arson and controlled demolition with explosives, representing over 80% of all identified damage sites;
- Between May 25 and August 18, 2012: Indications of additional building damages over this period (35), but some are due to further building/roof collapse at sites of earlier damage (thus likely within the November 24 to May 25, 2012 period).

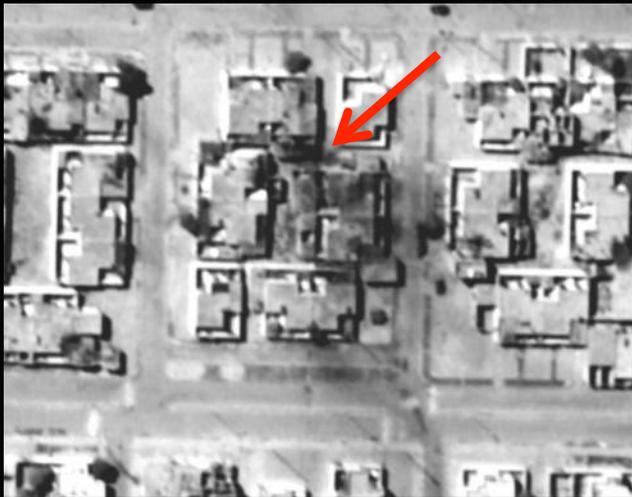
Site Location: 32.013N, 15.0572E

Multiple indications of a systematic and large scale campaign of arson directed at buildings in old and new Tawergha were identified, including three probable arson attacks in progress: active fires on the mornings of October 21 and November 24, 2011.

Imagery recorded on November 24, 2011

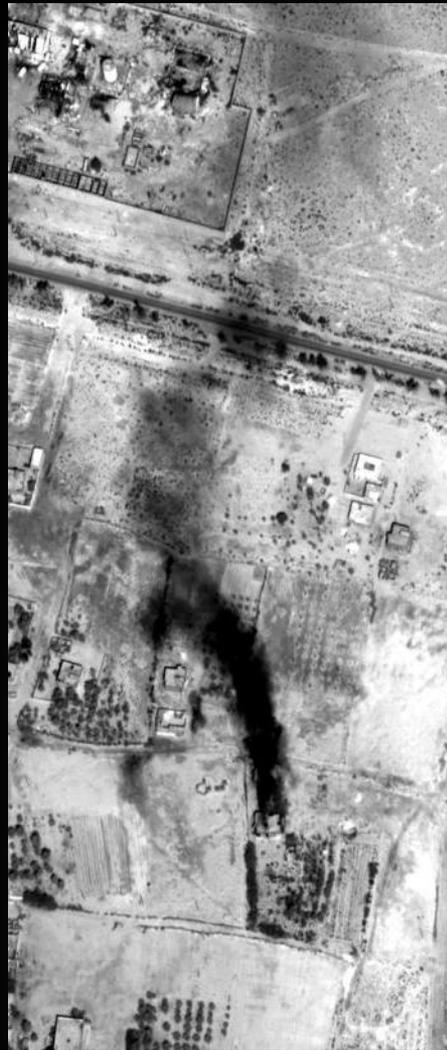
Site Location: 32.0194N, 15.0688E

Imagery recorded on October 21, 2011

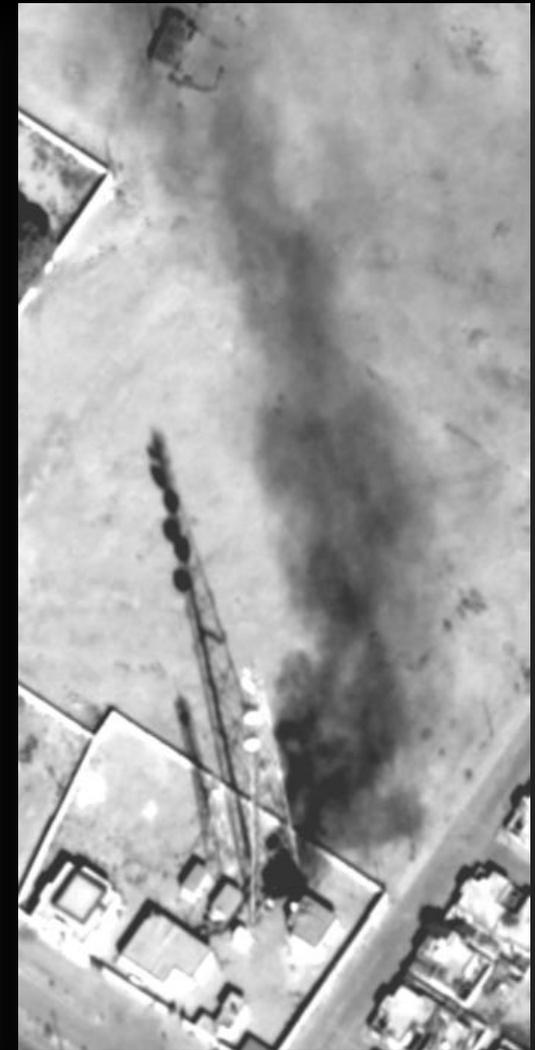
Site Location: 32.0156N, 15.0548E

Imagery recorded on November 24, 2011

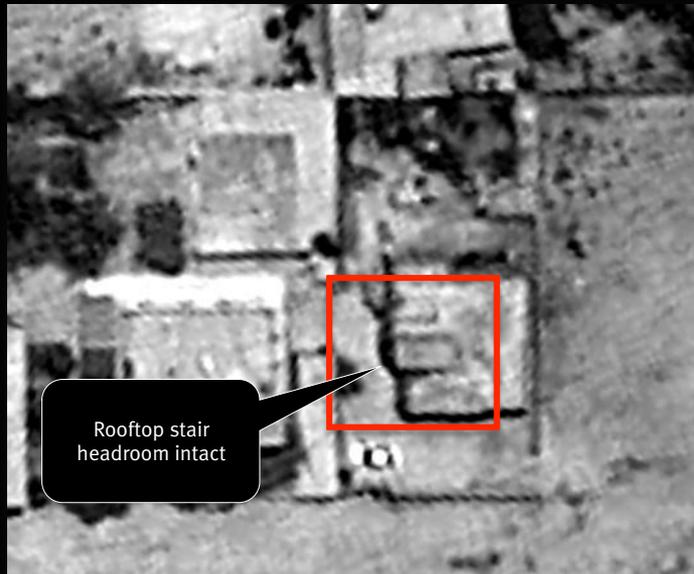
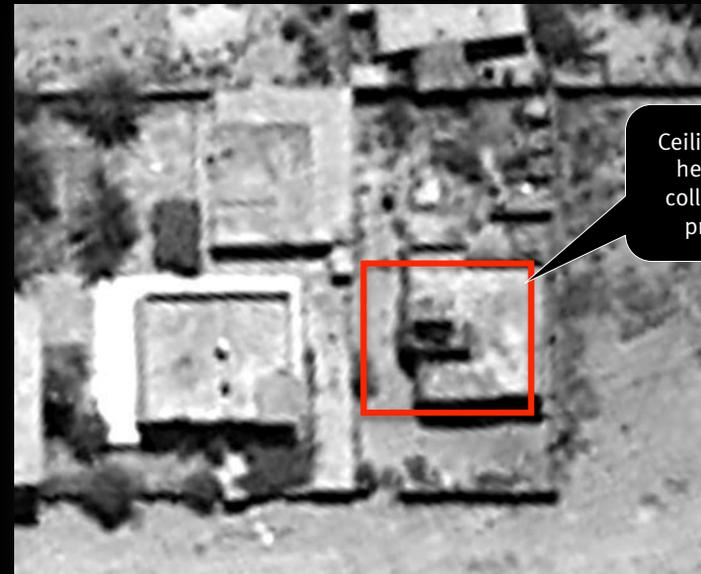
Site Location: 32.0007N, 15.0599E

Probable Fire-Related Building Damages: Case One

A common damage signature strongly associated with fire was the distinct collapse of the ceiling of stair headroom structures on building rooftops. In the case above, the ceiling has apparently burnt away or collapsed due to the channeling of fire upwards through the stairwell, indicating severe internal building damages.

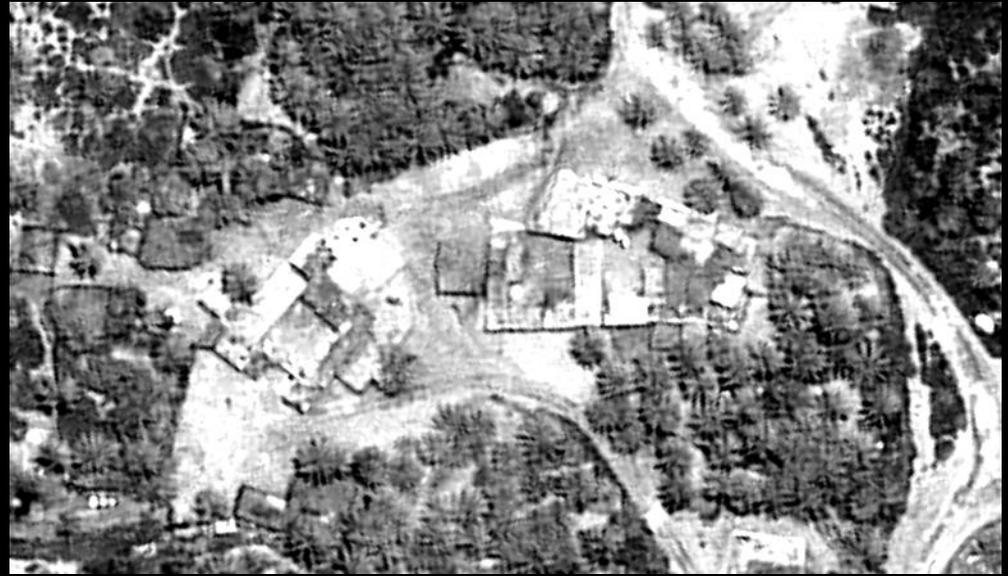
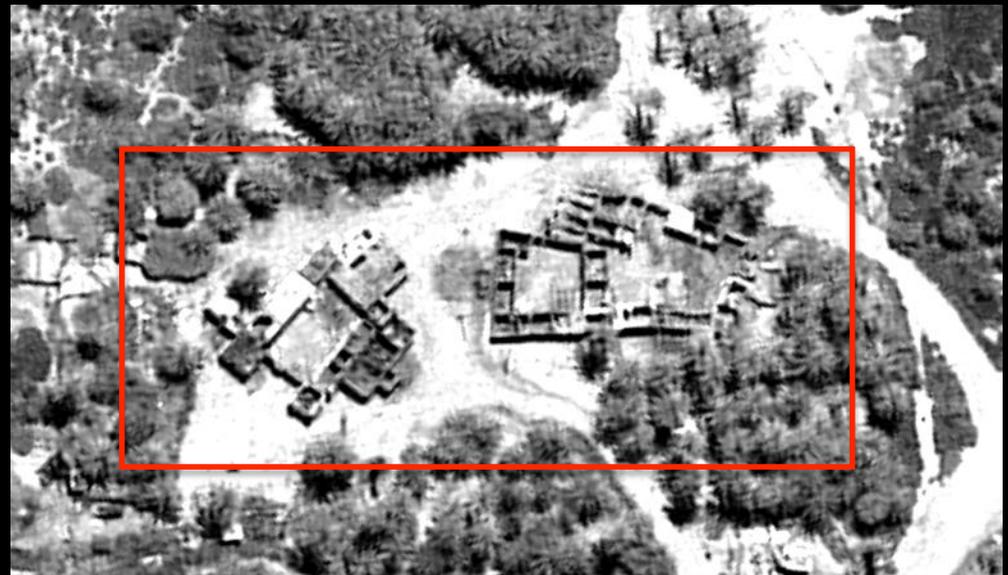
Site Location: 32.0252N, 15.1795E

Probable Fire-Related Building Damages: Case Two

A total of ten destroyed and severely damaged buildings were identified in a remote section of old Tawergha occurring between November 24, 2011 and May 25, 2012. The presence of intact load-bearing walls with destroyed rooftops strongly suggests that fire was the likely cause of these damages.

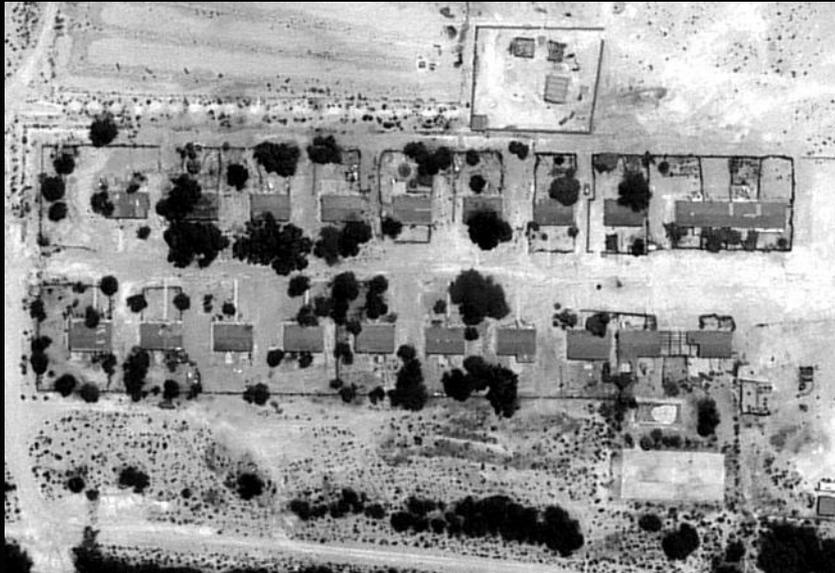
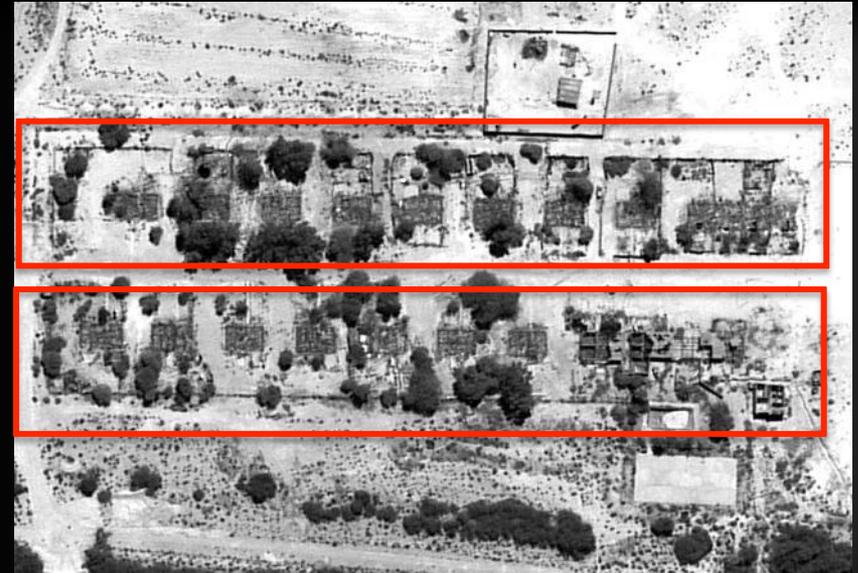
Site Location: 32.0296N, 15.0578E

Probable Fire-Related Building Damages: Case Three

A total of 22 destroyed buildings were identified within an apparent residential housing complex of new Tawergha. The damage signatures are fully consistent with fire as the likely cause of this destruction, which occurred between November 24, 2011 and May 25, 2012.

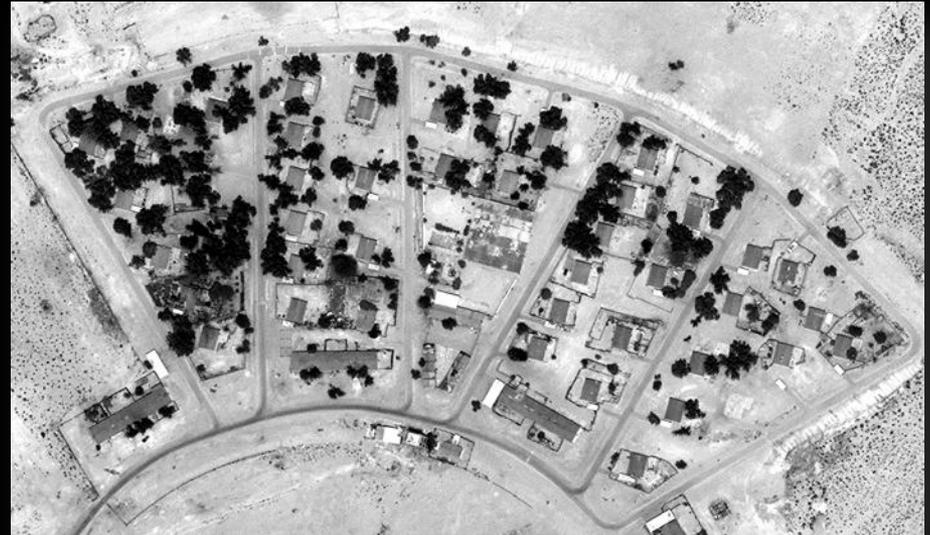
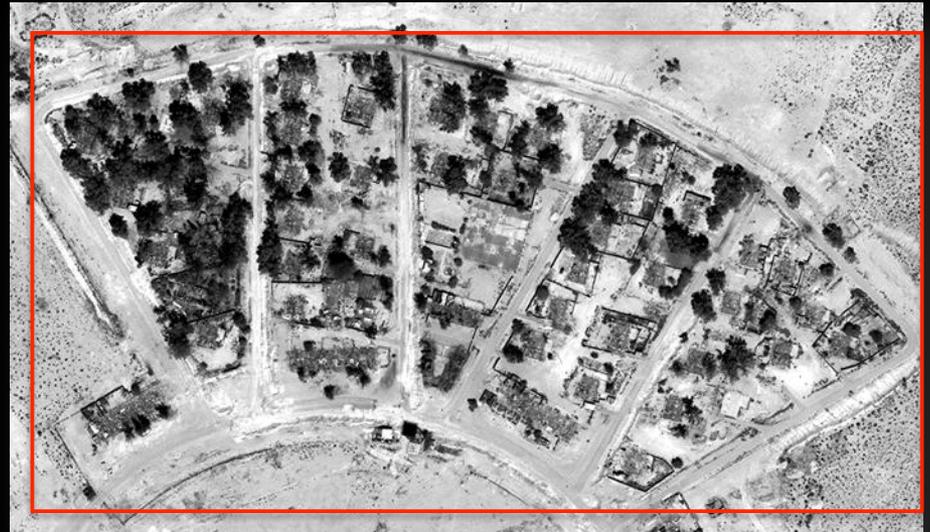
Site Location: 32.0266N, 15.061E

Probable Fire-Related Building Damages: Case Four

A total of 57 destroyed buildings were identified within an apparent large residential housing complex in new Tawergha. The damage signatures are fully consistent with fire as the likely cause of this destruction, which occurred between November 24, 2011 and May 25, 2012.

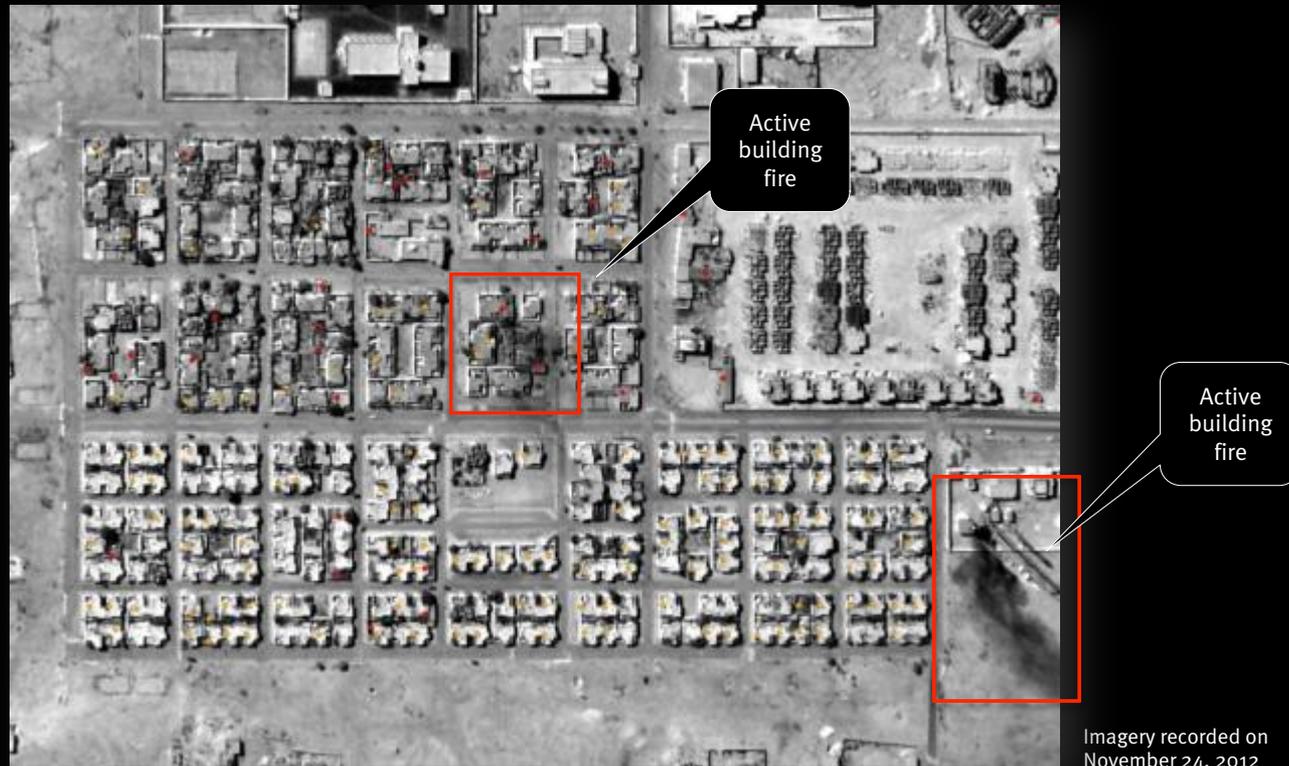
Site Location: 32.013N, 15.0572E

Probable Fire-Related Building Damages: Case Five

A total of 163 destroyed and severely damaged buildings were identified within two large residential housing complexes in new Tawergha. The damage signatures strongly suggest that fire was the cause of these damages—a conclusion reinforced by the presence of two active building fires on the morning of November 24, 2011. Because of the relatively light to moderate damage signatures common in these specific buildings (often limited to the ceiling collapse in stair headroom structures: see Case One) it is highly probable that fire-related damages have been significantly underestimated in this area. A majority of the structures (95) were damaged between July 28 and October 21, 2011, with the remainder of damages occurring after November 24, 2011.

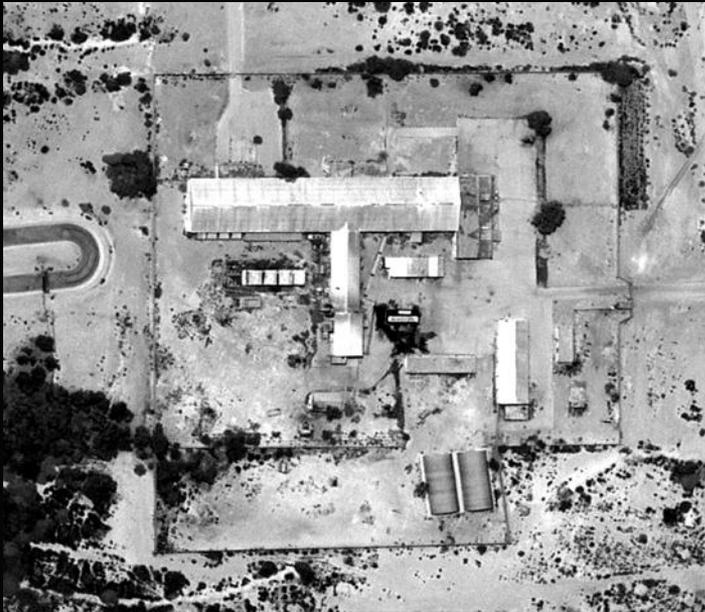
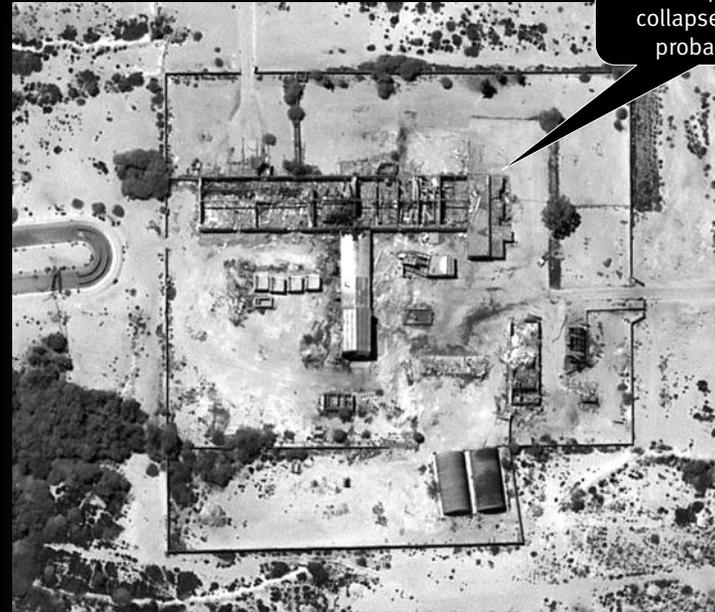
Site Location: 32.0195N, 15.0892E

Probable Fire-Related Building Damages: Case Six

A large warehouse complex located in eastern Tawergha was likely destroyed by fire, as indicated by the distinctive rooftop collapse, the presence of intact metal cross-beams and load-bearing walls, as well as the absence of artillery related impact cratering or debris signatures. Several smaller buildings within the complex were likely destroyed by fire between October 21 and November 24, 2011, with the destruction of the main warehouse occurring between November 24, 2011 and May 25, 2012.

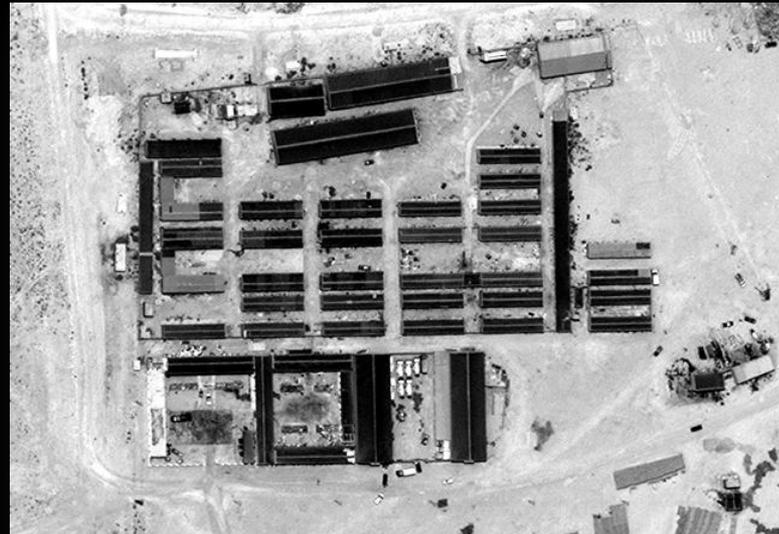
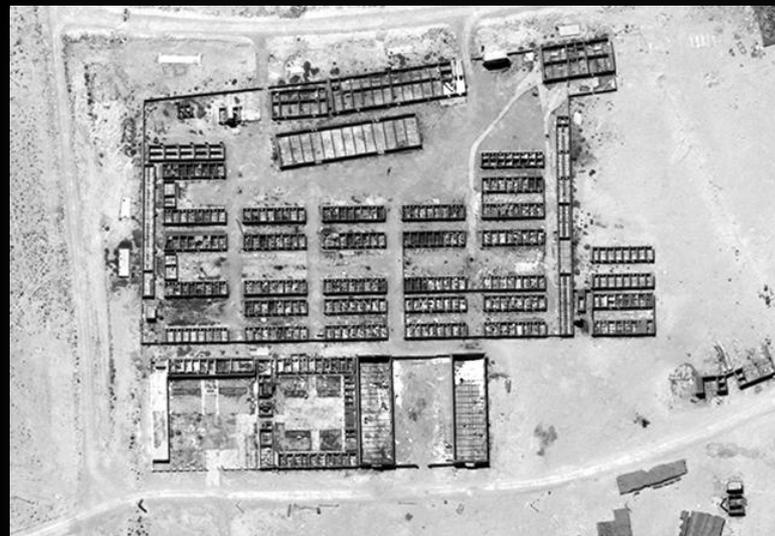
Probable Fire-Related Building Damages: Case Seven

A large warehouse complex in western Tawergha with over 40 structures was likely destroyed by fire, as indicated by the distinctive rooftop collapse, the presence of intact metal cross-beams and load-bearing walls, as well as the absence of artillery related impact cratering or debris signatures. The entire complex was likely destroyed by fire between November 24, 2011 and May 25, 2012.

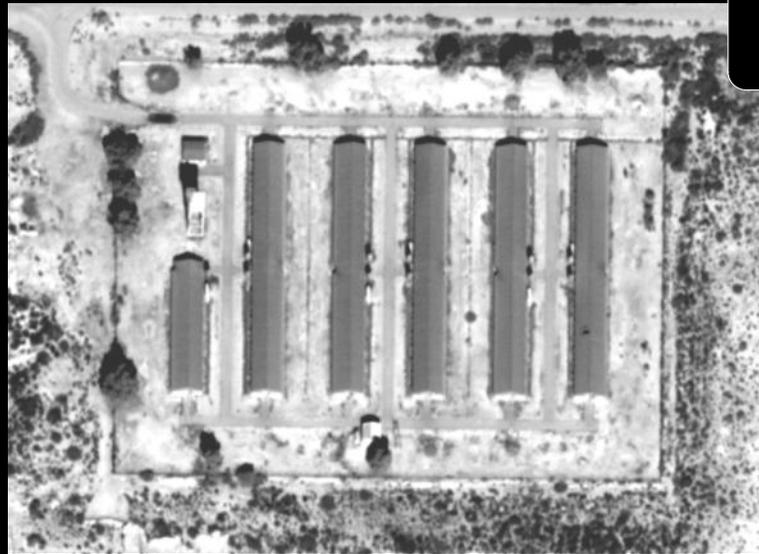
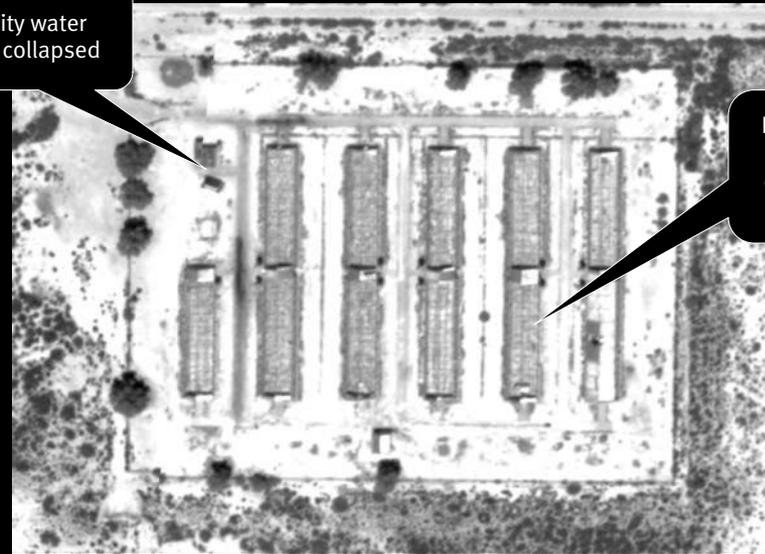
Site Location: 32.0342N, 15.0954E

Facility water tower collapsed

Rooftops appear to have partially collapsed due to probable fire

Probable Fire-Related Building Damages: Case Eight

The large complex of poultry farms located on the northern edge of Tawergha was likely destroyed by fire, as indicated by the distinctive rooftop collapse, the presence of intact load-bearing walls, as well as the absence of artillery related impact cratering or debris signatures. The facility water tower was also knocked down. The entire poultry complex was likely destroyed between November 24, 2011 and May 25, 2012.

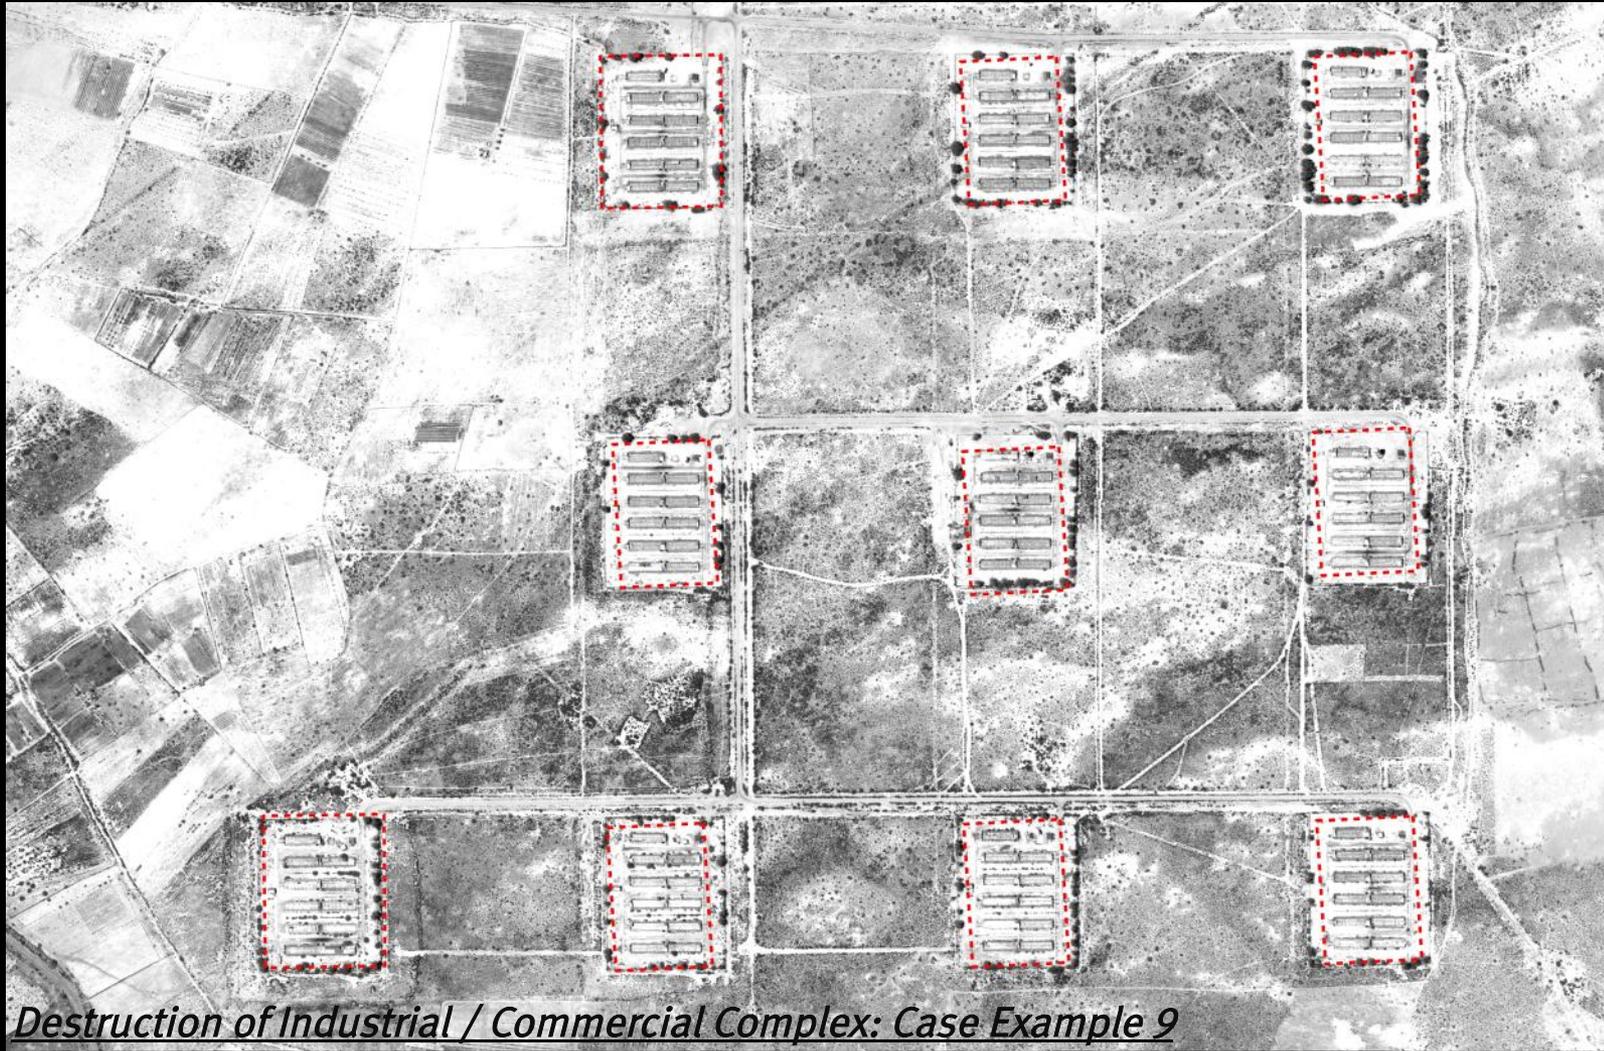
Site Location: 32.037N, 15.095E

Destruction of Industrial / Commercial Complex: Case Example 9

Overview of 10 poultry farm units destroyed between November 24, 2011 and May 25, 2012.

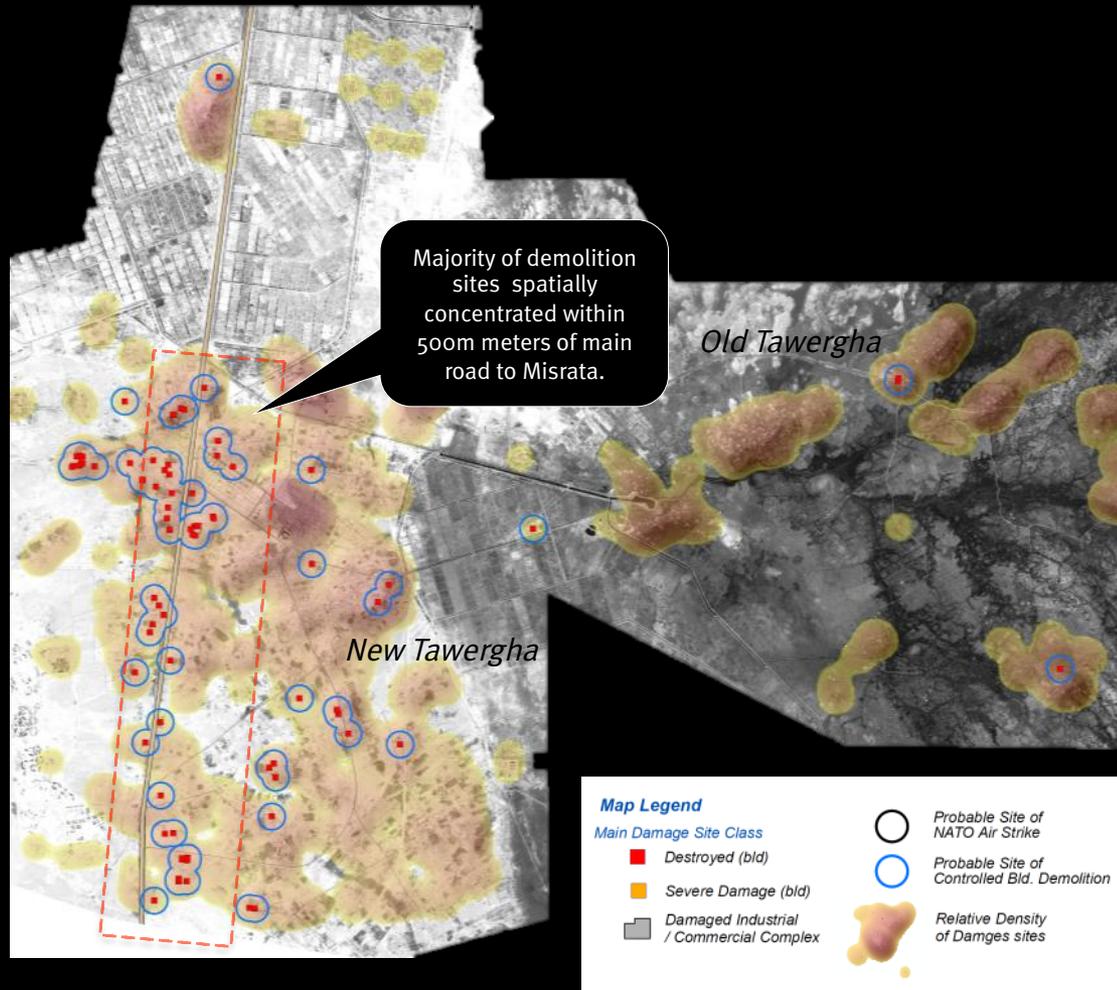
Demolition Overview

A total of 81 buildings and two municipal water towers were identified as likely destroyed by controlled demolition with explosives. Ninety-six percent of the demolished building sites were in new Tawergha, with 52% of them concentrated within 500 meters of the main road leading north to Misrata. Satellite imagery corroborated videos that apparently showed several demolitions, representing further evidence of an organized campaign to destroy the town.

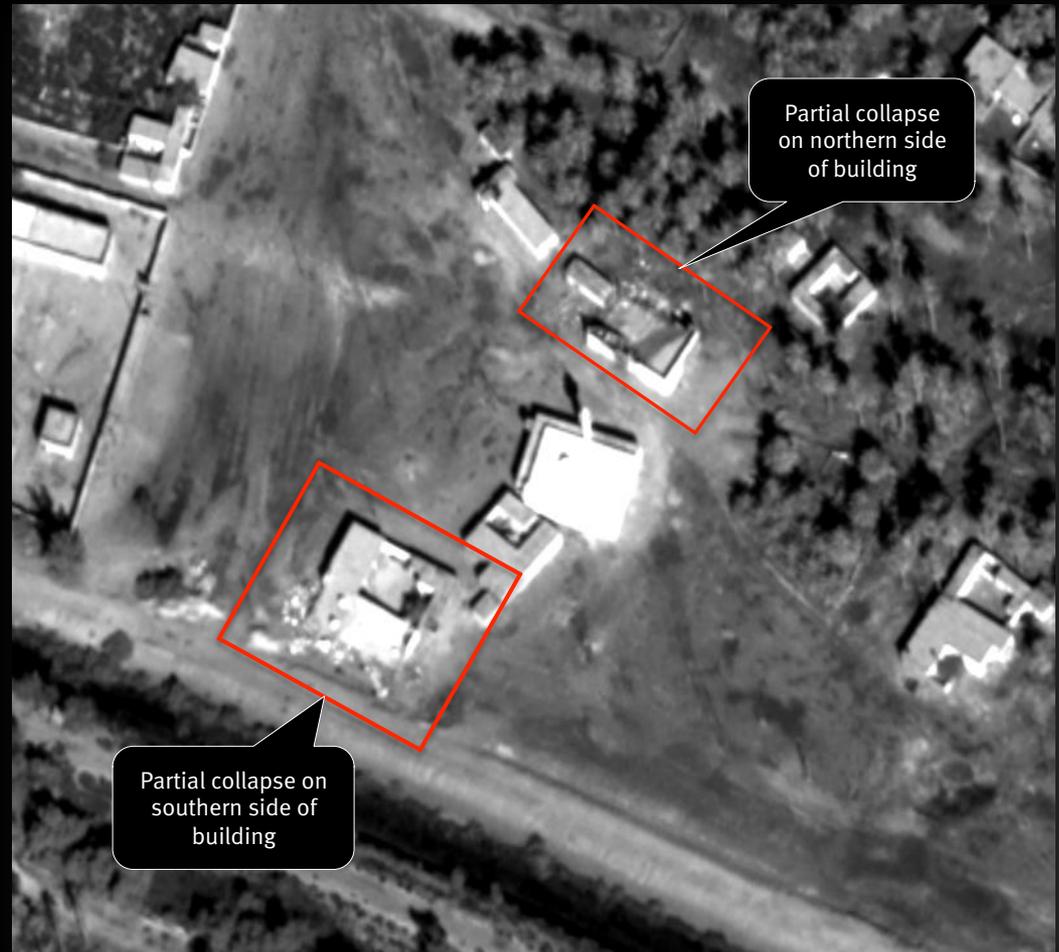
Site Location: 32.0109N, 15.1044E

Probable Building Demolition: Case One

Two single story buildings next to the main irrigation facility were destroyed between October 21 and November 24, 2011. Both sites show signs consistent with controlled demolition with explosives (i.e. the partial collapse of each structure, limited associated debris fields and partially intact rooftops).

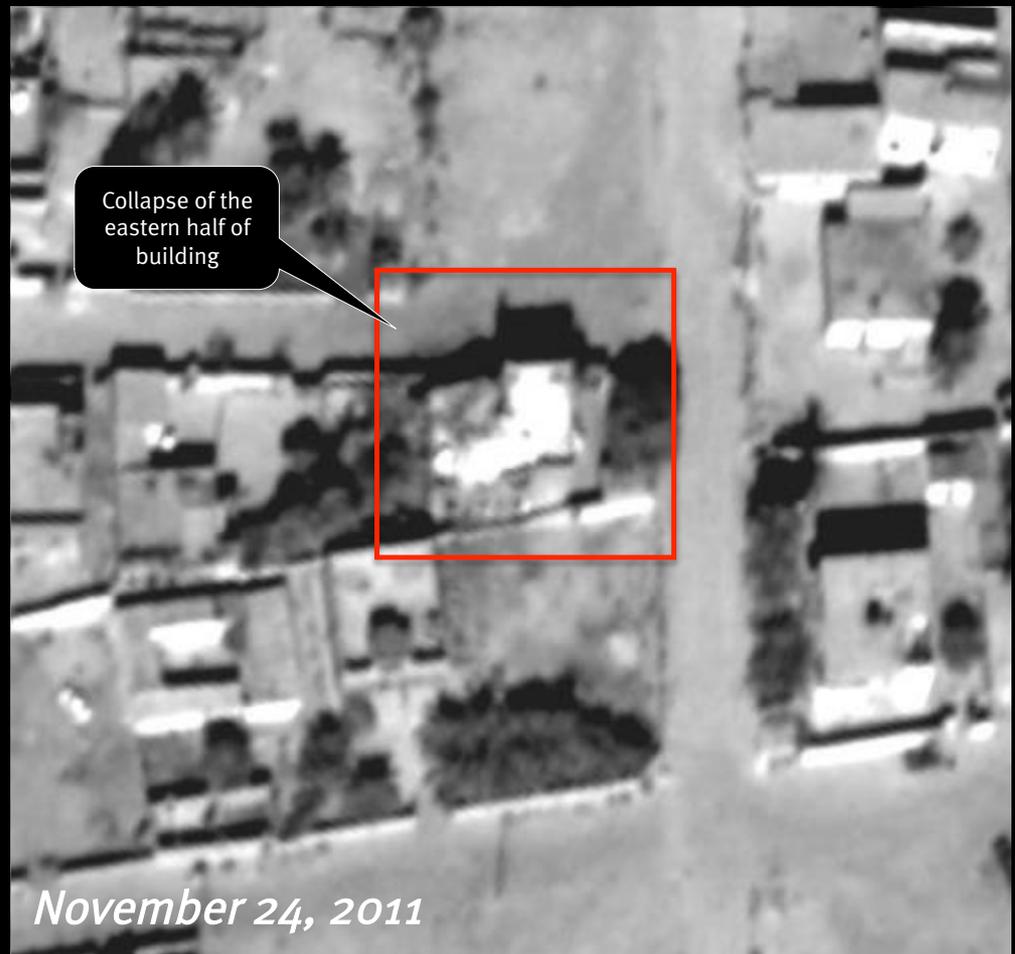
Site Location: 32.0044N, 15.0709E

Probable Building Demolition: Case Two

A three-story building located in central Tawergha was likely destroyed between October 21 and November 24, 2011. The apparent near vertical collapse of approximately half of the building is consistent with the use of explosives.

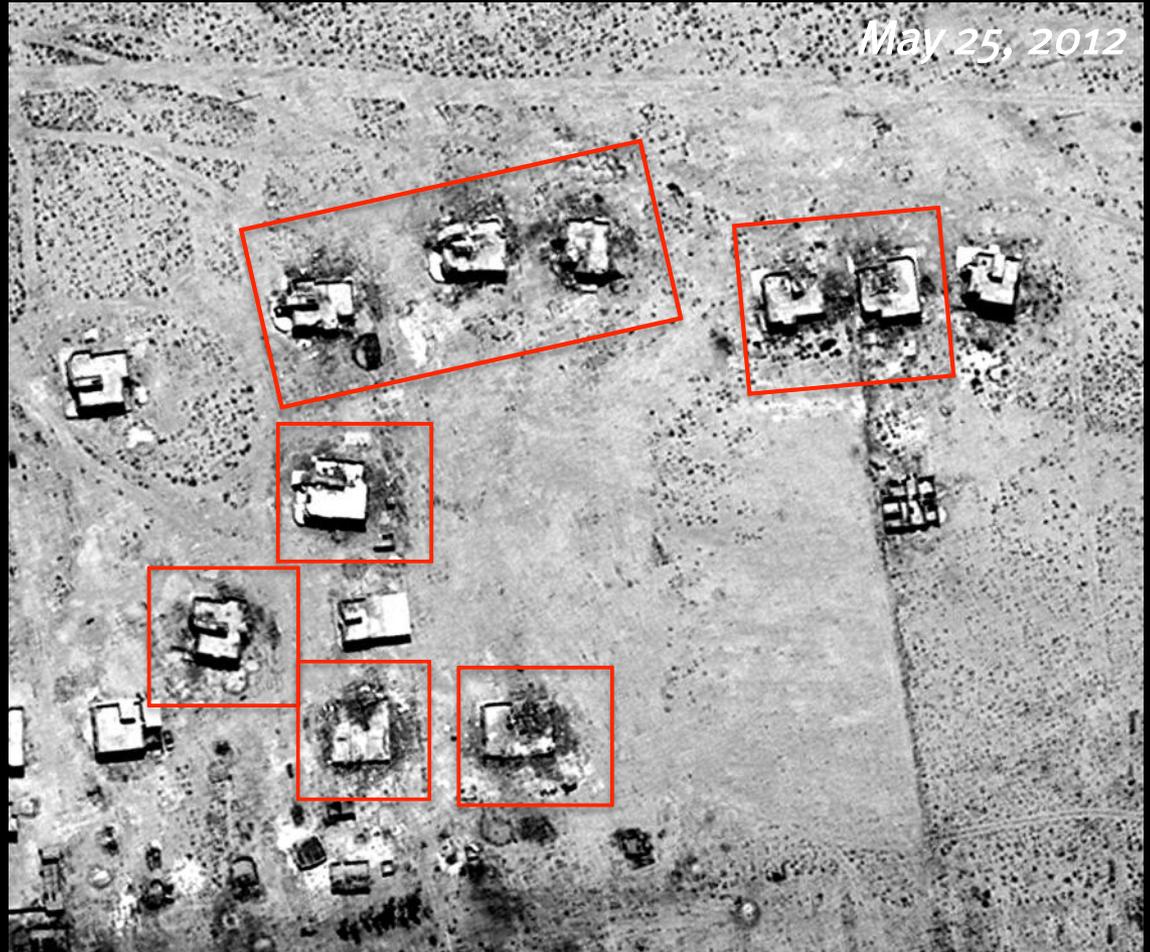
Probable Building Demolition: Case Three

The largest concentration of demolished buildings was located on the western edge of Tawergha, approximately 1.4 km from the main road to Misrata. A total of ten apparent residential buildings (nine pictured at right) were destroyed between November 24, 2011 and May 25, 2012. All building sites show signs consistent with a controlled demolition: the partial collapse of each structure, associated debris fields, and the rooftops partially intact.

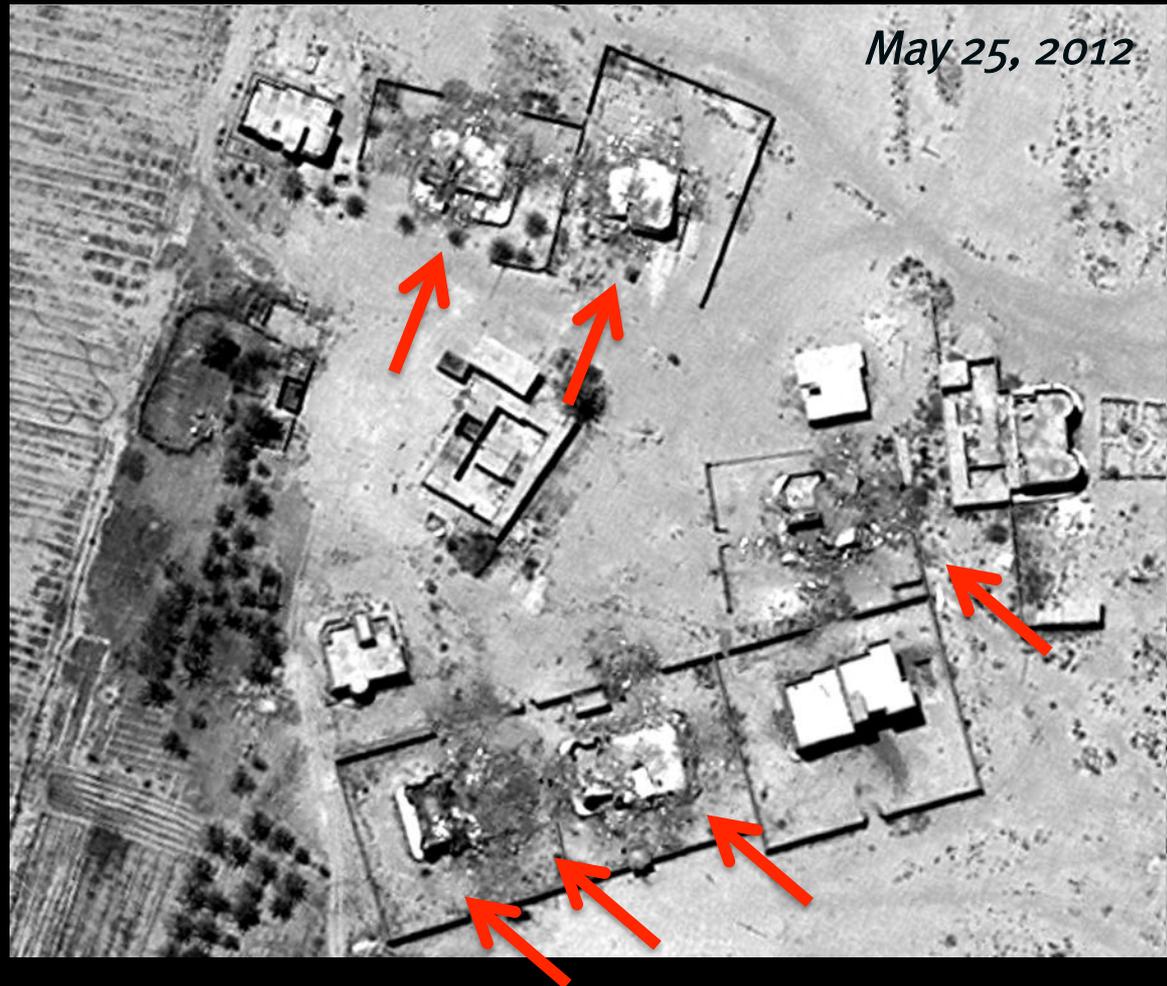
Probable Building Demolition:
Case Four

The second largest concentration of demolished buildings was located approximately 120 meters from the main road to Misrata. A total of six apparent residential buildings were destroyed between November 24, 2011 and May 25, 2012. All buildings have been completely destroyed with damage signatures consistent with large explosive events. Such signatures are typical of air strikes or heavy artillery shelling, but ground fighting and NATO air strikes had stopped three months before the period of destruction (after November 24, 2011). These buildings were therefore likely demolished with significantly more explosives than the other suspected demolition sites in Tawergha.

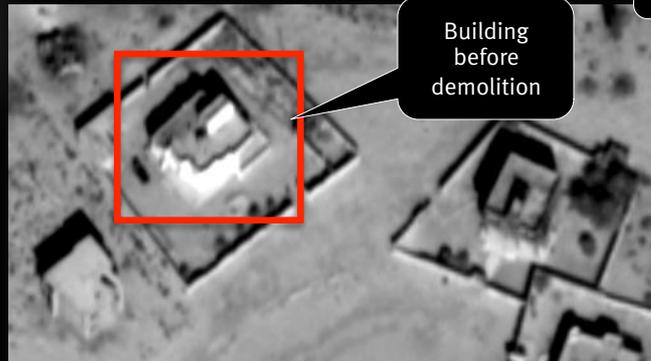
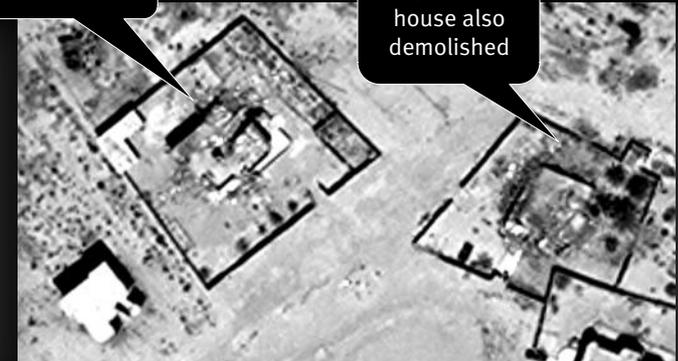
Site Location: 31.9657N, 15.0515E

Building before demolition

Building after demolition

Second house also demolished

Video of Housing Demolition – Site Identified in Satellite Imagery: Case Five

Video posted on YouTube in March 2012 shows the controlled demolition of an apparent residential compound. The site was identified in satellite imagery, confirming the demolition location in southern Tawergha, as well as the time period the video when was likely recorded (between November 24, 2011 and March 2012).

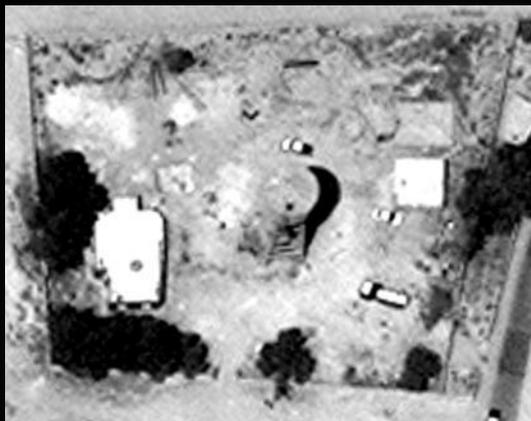
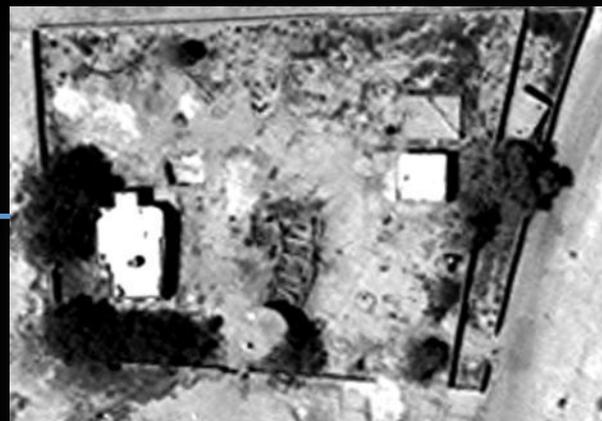
Site Location: 32.007N, 15.0602E

Video of Water Tower Demolition – Site Identified in Satellite Imagery: Case Six

Video posted on YouTube in April 2012 shows the controlled demolition of a municipal water tower. The site was identified in satellite imagery, confirming the demolition location in central Tawergha, as well as the time period in which the video was likely recorded (between November 24, 2011 and April 2012).
